## External Barrel and Handguard Temperature of the 5.56mm M4 Carbine

**Final Report**

September 1994

### TECHNICAL REPORT NO. SMCAR-ES-94-1

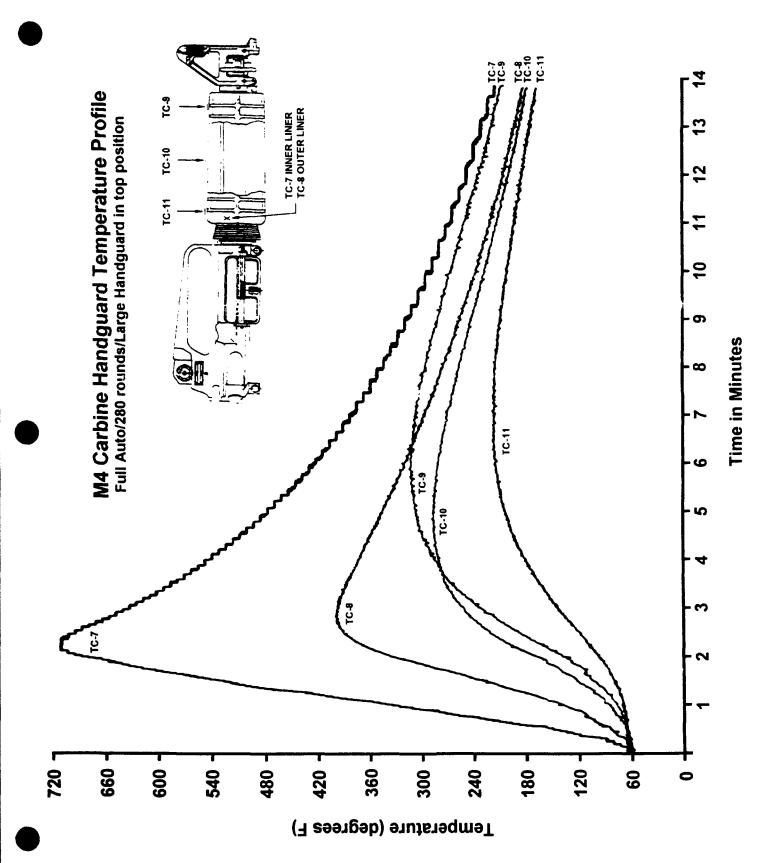
FIGURE 13 Handguard Temp. for Large Handguard

- 6.1.7 Handguard thermocouple temperature for full automatic fire for the large handguard in the top position is shown in Figure 13. As shown in this graph, the temperature of the inner liner is by far the hottest portion of the handguard. The temperature of the outside of the handguard plastic reached a point at which it could not be comfortably held with the base hand in about two minutes, with the temperature being highest near the front of the handguard. (A handguard temperature of 150 degrees Fahrenheit is considered the temperature at which the handguard could not be comfortably held.) It can also be seen the maximum temperature of the outer portion of the handguard occurs after about 6 minutes or about 4 minutes after the firing has ended and maximum barrel temperature has been achieved.

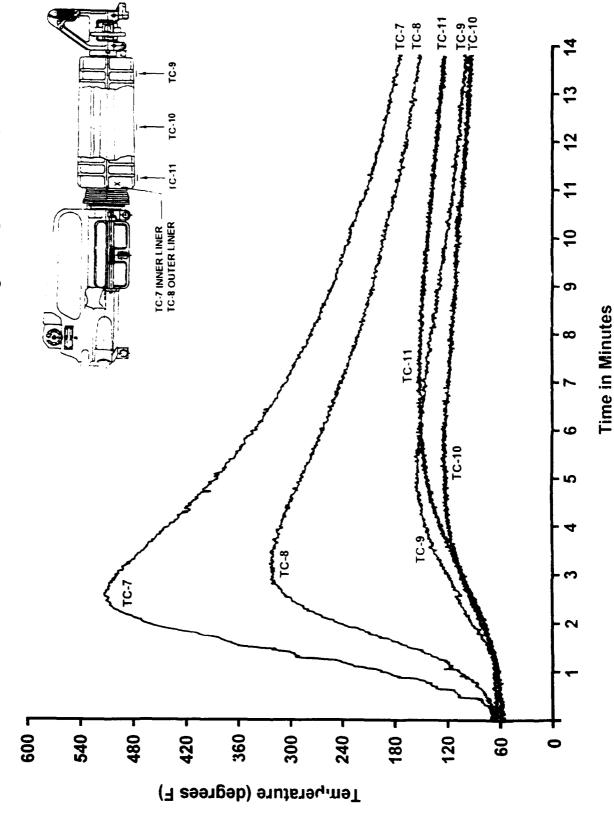
FIGURE 14 Handguard Temp. for Large Handguard

- 6.1.8 Handguard thermocouple temperature for full automatic fire for the large handguard in the bottom position is shown in Figure 14. In the bottom position on the weapon, all thermocouples locations are significantly cooler than when the handguard is in the top position. The outside of the handguard never reached the 150 degree Fahrenheit threshold.
